Manhole Inspection Summary

Manhole # S17YY_007MH

Inspection ☐ Is Incomplete Rating: **4) Poor**

Location Address: **2568 DRUID PARK DR**

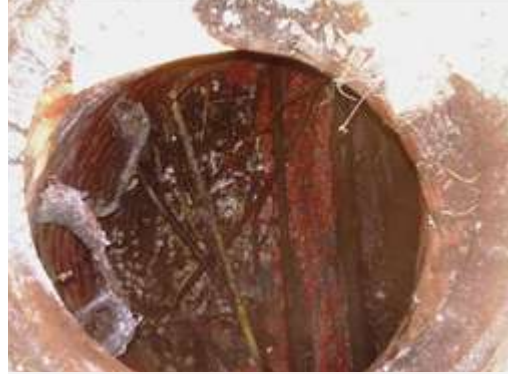
Top View

Corroded steps. Bench debris.

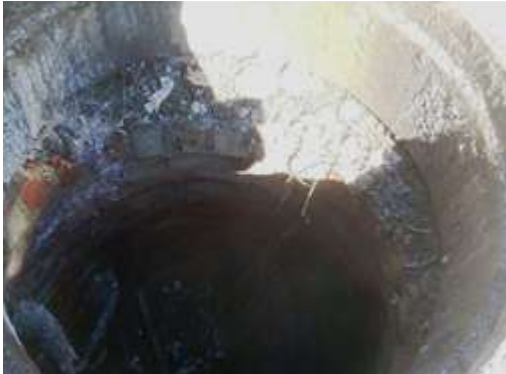
Defect

Frame leaks. Frame offset. Adjustment root intrusion, deterioration and infiltration. Barrel infiltration - other side.

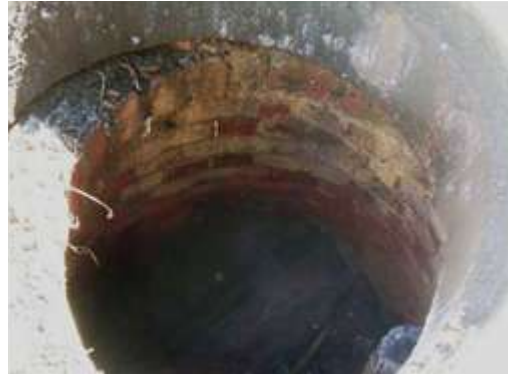
Defect

Frame leaks. Frame offset. Adjustment root intrusion, deterioration and infiltration. Barrel infiltration.

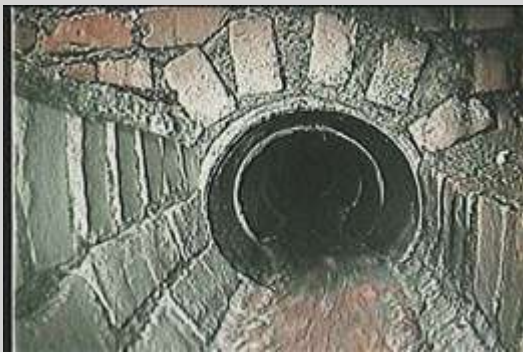
10 in. Circular Gravity Sewer Pipe Out @ 12 O'Clock

Channel deterioration.

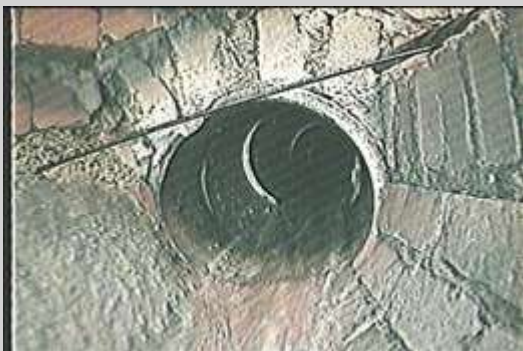
10 in. Circular Gravity Sewer Pipe In @ 6 O'Clock

Barrel deterioration and infiltration.
